Surface changes of orthodontic brackets following treatment with fixed orthodontic appliances

Abstract

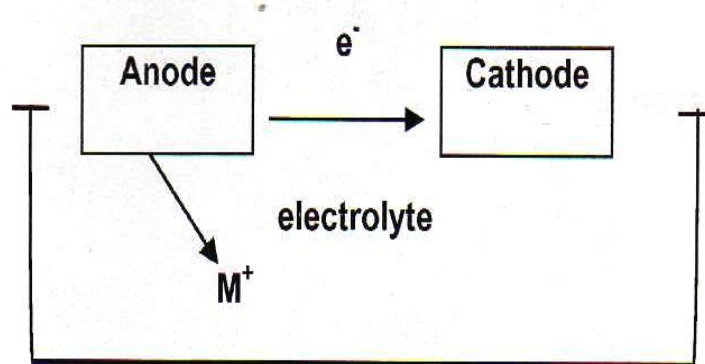
Fig. (1) Electrochemical cell

looks as an electrochemical cell. The anode is the site where the positive ions are formed while the cathode represents the site at which the free electrons of the anode were consumed (Fig.1). The larger the cathode and the smaller the anode was the greater destruction⁽²⁾,

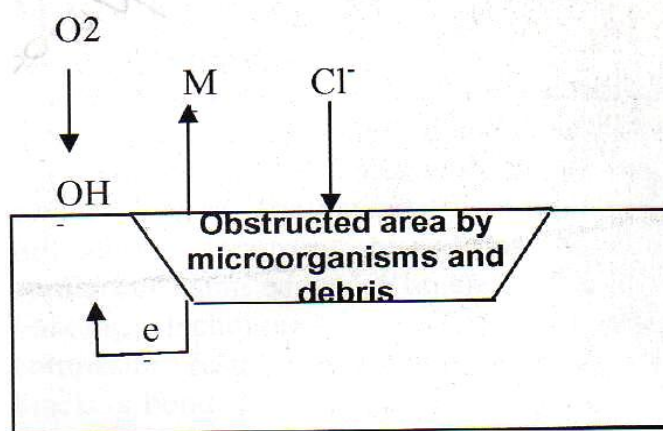
Fig. (10): Role of micro-organisms in the development of corrosion
